Contract #: 04-0120F4Cty: SF/ALA Rte: 80 PM: 13.2/13.9File #: 69.28**WELDING INSPECTION REPORT****Resident Engineer:**Siegenthaler, Peter**Address:** 333 Burma Road**City:** Oakland, CA 94607**Report No:** WIR-020980**Date Inspected:** 25-Feb-2011**Project Name:** SAS Superstructure**OSM Arrival Time:** 1500**Prime Contractor:** American Bridge/Fluor Enterprises, a JV**OSM Departure Time:** 300**Contractor:** Zhenhua Port Machinery Company, Ltd (ZPMC), Changxing Island **Location:** Shanghai, China**CWI Name:** Mr. Lv Li Qing**CWI Present:** Yes No**Inspected CWI report:** Yes No N/A**Rod Oven in Use:** Yes No N/A**Electrode to specification:** Yes No N/A**Weld Procedures Followed:** Yes No N/A**Qualified Welders:** Yes No N/A**Verified Joint Fit-up:** Yes No N/A**Approved Drawings:** Yes No N/A**Approved WPS:** Yes No N/A**Delayed / Cancelled:** Yes No N/A**Bridge No:** 34-0006**Component:** BAY14 OBG**Summary of Items Observed:**

BAY14

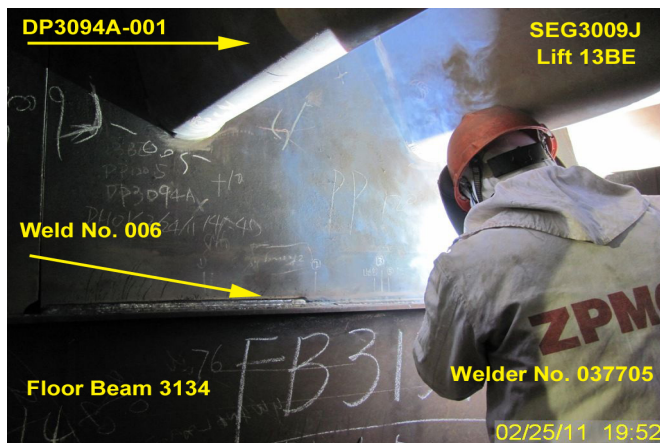
FCAW welding of complete joint penetration weld joint(s) located on lift 13B East Line SEG3009J Floor Beam Diaphragm to Floor Beam weld number(s) 006. Welder is identified as welder no. 037705. The welding variables recorded by ZPMC QC identified as Zhan Hai Feng appeared to comply with applicable WPS(s) WPS-B-T-2232-TC-U4b-FCM-1. See attached photo

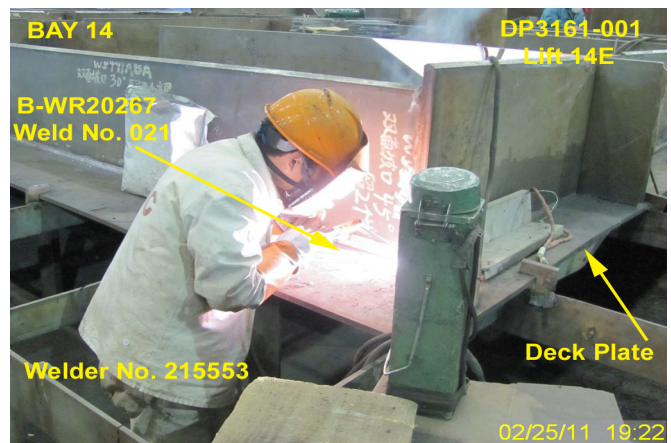
SMAW welding of complete joint penetration weld joint(s) located on lift 14 East Line DP3161-001 Floor Beam Diaphragm to Deck Panel weld number(s) 021. Welder is identified as welder no. 215553. The welding variables recorded by ZPMC QC identified as Zhan Hai Feng appeared to comply with applicable WPS(s) WPS-345-SMAW-2G (2F)-FCM-Repair-1 and B-WR-20267. See attached photo
